Real Time Pricing Issue – 12 November 2009

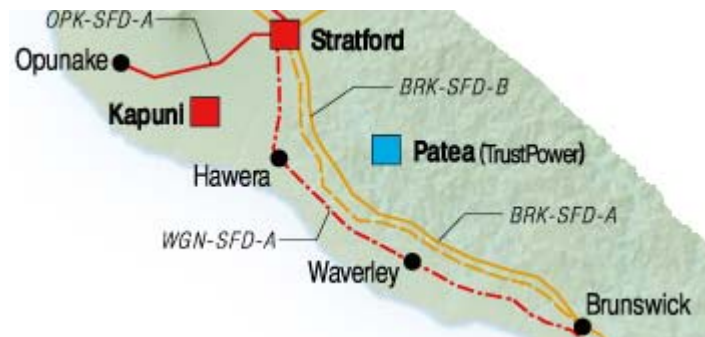
As a result, the BRK_SFD_3_HWA_ABSS_DISABLED_S_O_1Aof2_Z constraint was applied for the duration of this outage. This constraint was put in place to limit the pre-contingency flows from Stratford to Hawera (HWA_SFD1.1) and Stratford to Brunswick (BRK_SFD1.1).

From 07:00 to 09:00 the BRK_SFD_3_HWA_ABSS_DISABLED_S_O_1Aof2_Z constraint was either binding or was broken. This caused a spring washer effect to occur meaning the price at the sending end of the constraint was significantly lower than the price at the receiving end.

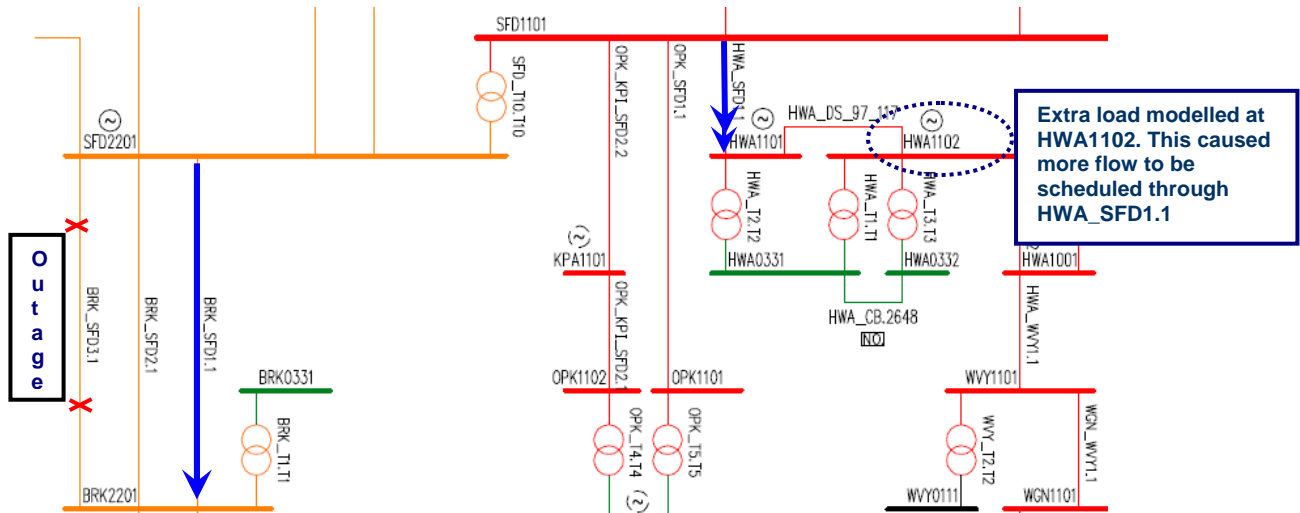
The System Operator's investigation has revealed that the load value used as an input to Real Time Prices for the HWA1102 node had been incorrectly mapped to a gross load value. This is explained below.

At Hawera (HWA1102), the Whareroa generation (WAA) is dispatched to a figure after taking into account the embedded WAA load. Mapping HWA1102 node to a gross load value meant that the WAA load was counted twice.

The double counting of the WAA load caused more flow to be scheduled through Stratford to Hawera (HWA_SFD1.1) to supply this extra load as illustrated in the figure below.

Since this event occurred the System Operator has undertaken further investigation to identify where net generation and embedded loads exist to identify any further potential problems of the same nature. This has identified a number of other nodes which have subsequently been remapped to prevent a similar problem arising in the future.
